## Case Study: Refurbishment Services

# Zenith gives Covpress building a new lease of life

Client: Covpress

Project: Painting & Decorating

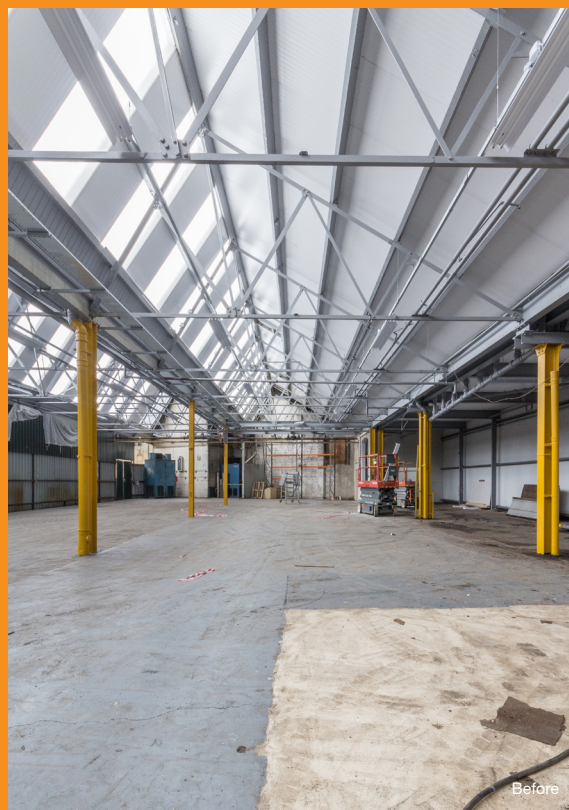
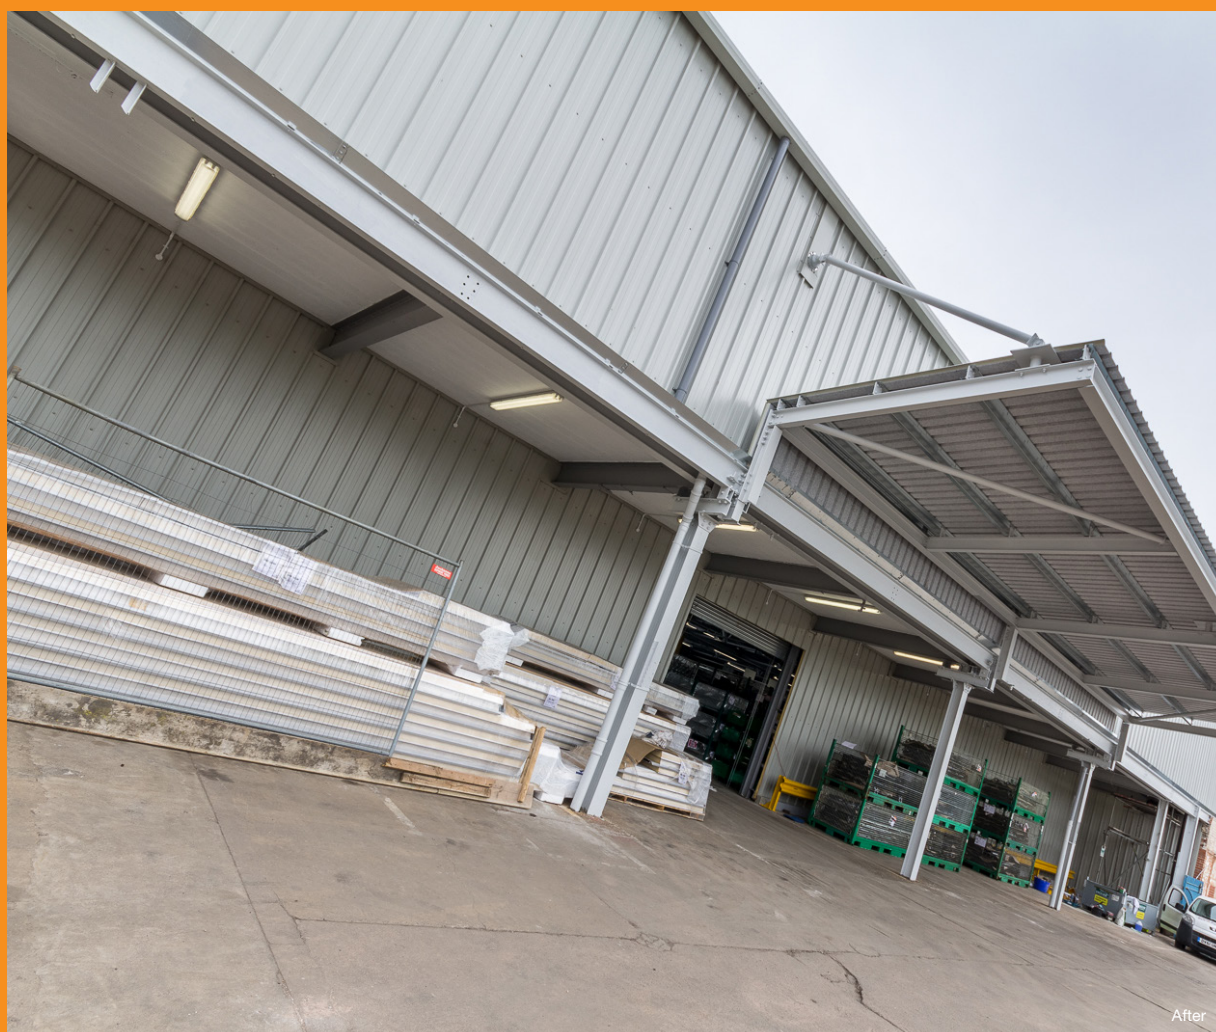
The third phase involved the removal, by hand, of old flaking paint and efflorescence, (caused by years of water ingress to the concrete ceiling and brick walls), after which the ceiling was treated with Johnstone's stabilising solution.

Finally, the building was finished with Johnstone's White Pliolite Masonry Paint, Dark grey Steel & Cladding Alkyd Based paint and light grey oil base eggshell finish ensuring an attractive, hardwearing finish, giving a new lease of life to an ageing building, ensuring it remains fit for purpose well into the future.
